**SAS Superstructure**

**Daily Diary Report by Bid Item**

Contract No.: 04-0120F4

**04-0120F4  
04-SF-80-13.2/13.9  
Self-Anchored  
Suspension Bridge****Weather**

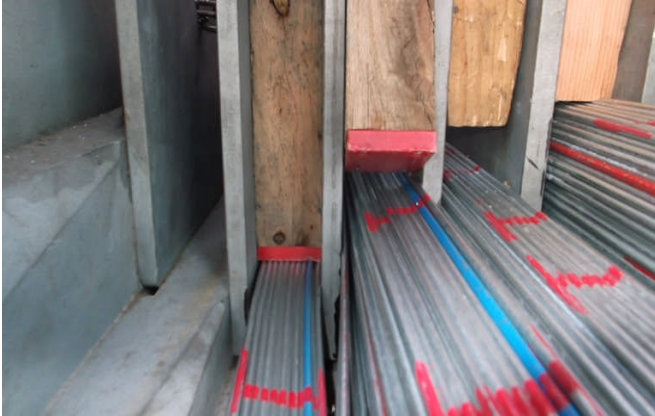
Post Rough-Adjusting of Strands 55&56 (SouthSaddle3)

NOTE: It was interesting to see the contrast between strands #55 & 56 (South) following the RA operation. As shown in the photos, the wood block on #56 did move as a result of the adjusting (with no one banging on it) and resulted in the serious banking of the wires. Somehow (due to friction, maybe) the two adjacent strands did behave 180 degree differently with one banking and one staying flat with no one driving the wood block. But, it proved the point that as long as the compression (pressure) is maintained on the strand, it will not bank. I showed this behavior to Roman and he took some photos (see the attached photos.)
